Karoo Access Profile as at March 2011:

Karoo National Park's entrance gate, rest camp and reception building

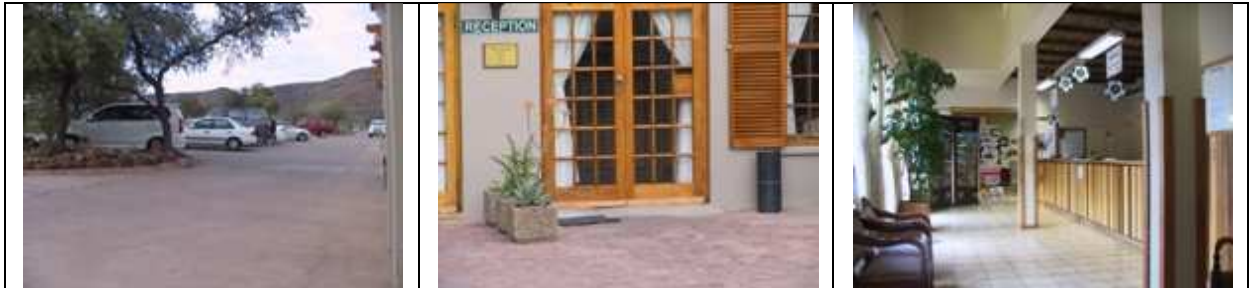
The parking at the park's main complex is open plan and on a slight slope. The park does plan to designate a wheelchair parking with sufficient width on level ground. There is a ridge at the entrance into the reception facility which some wheelchair users may not be able to negotiate without assistance. Inside the reception counter is all one level and there is not currently a lowered section for wheelchair guests.

Parking, reception entrance and reception desk

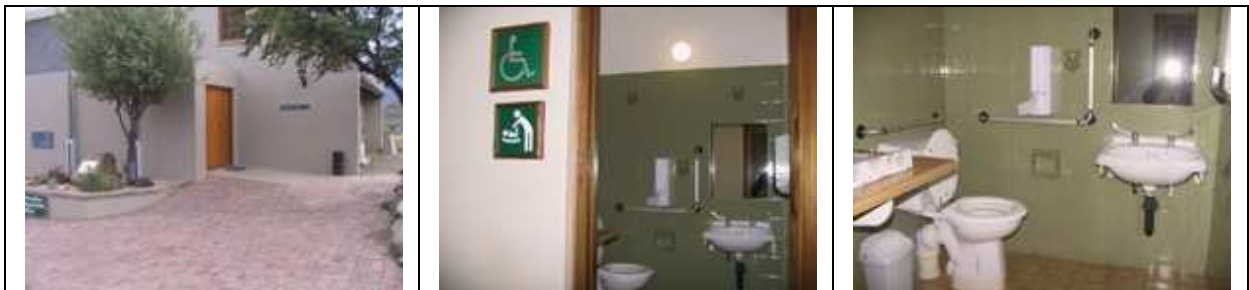
There are accessible public toilets at the main reception/restaurant complex, which meet the required standards.

Accessible public ablution and baby changer at park's main complex

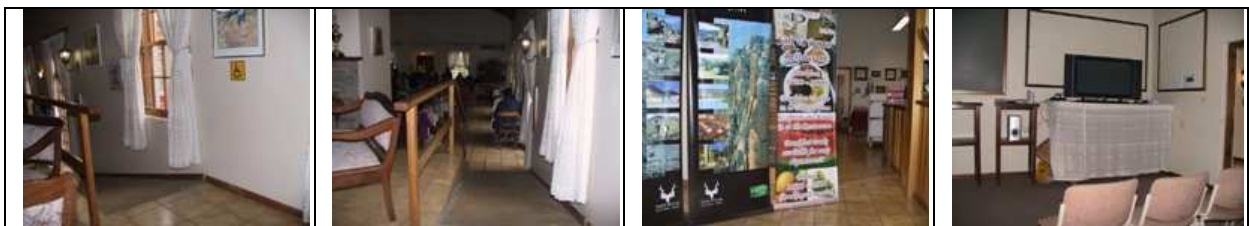
Inside the building the reception area, shop and meeting hall/audiovisual room are all easily accessible. The restaurant is accessed via a very steep ramp and assistance will be required to negotiate this.

Accessibility within the main complex building

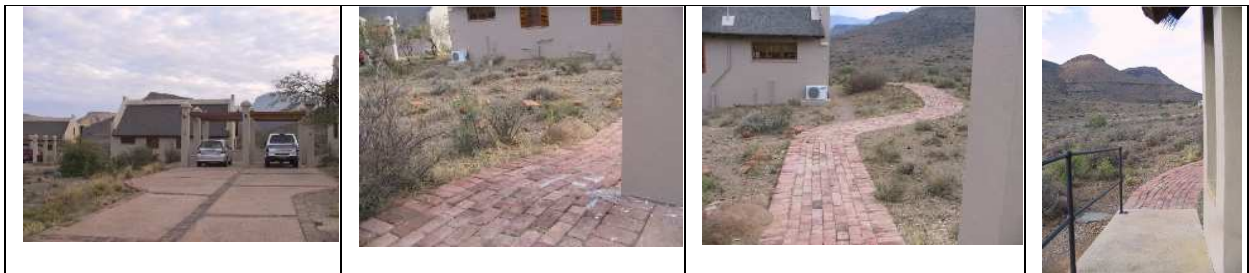
Accessible Chalets: The 2 three-bed accessible chalets' parking are relatively accessible. The parking area is flat and there is sufficient width for wheelchair users to move to and from their vehicle. There are some pillars flanking the parking zone which will need to be avoided when parking to insure they don't interfere with the open door where a wheelchair user must disembark. The pathway from the parking to the units is a little uneven and steep in places, but once one gets to the unit it becomes smoother and a support rail is provided to prevent anyone going over the side of the ramp.

Karoo Accessible Chalets parking and access path

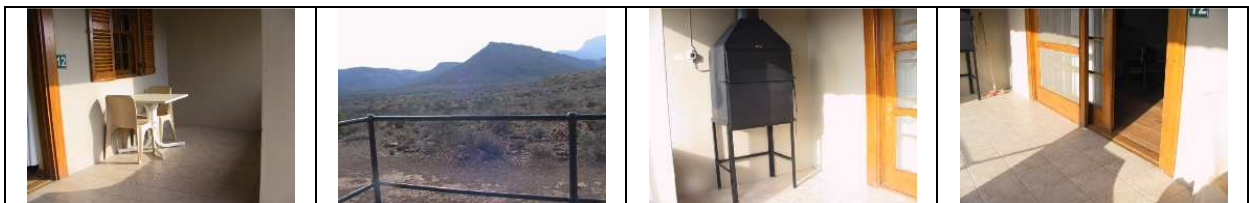
The veranda is flat and spacious and a rail provides safety for those admiring the view. The fold down braai is relatively accessible to use from a wheelchair. There is a ridge to get into the units' interiors which may challenge some in entering the unit which is done via a sliding door that does open a sufficient distance to accommodate wheelchair passage.

Karoo Accessible Chalet - veranda

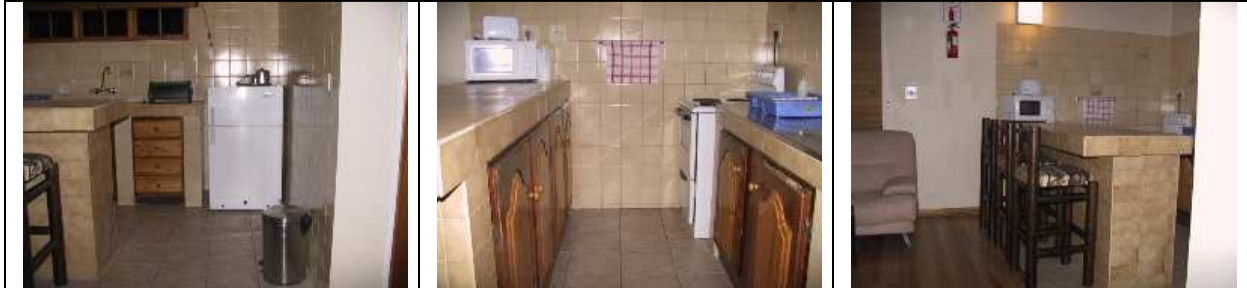
The kitchen is an open plan extension of the bedroom chamber and it does not have any adaptations for guests in wheelchairs such as clearance below the sink and hot plates. It is also somewhat cramped but there is space to manoeuvre alongside these facilities and the fridge can be accessed easily. The eating

bar is a little high for a person in a chair and perhaps when these units are next subject to refurbishment the kitchen can be adapted to be more accessible to guests in wheelchairs.

Accessible Chalet kitchen.

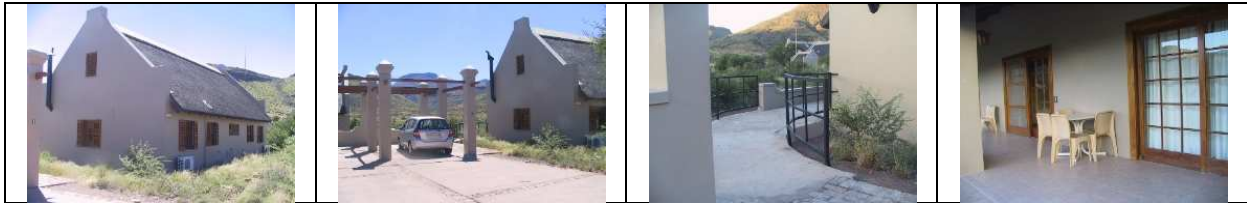
Accessible Guest Cottage: The accessible guest cottage has a similar parking set-up to the chalets, but the access path to the unit is much more accessible and the ridge into the unit is much more negotiable. The unit's veranda is a spacious flat area and entrance into the building and access to the fold down braai are both easily achieved in a wheelchair.

Karoo Accessible Guest Cottage exterior

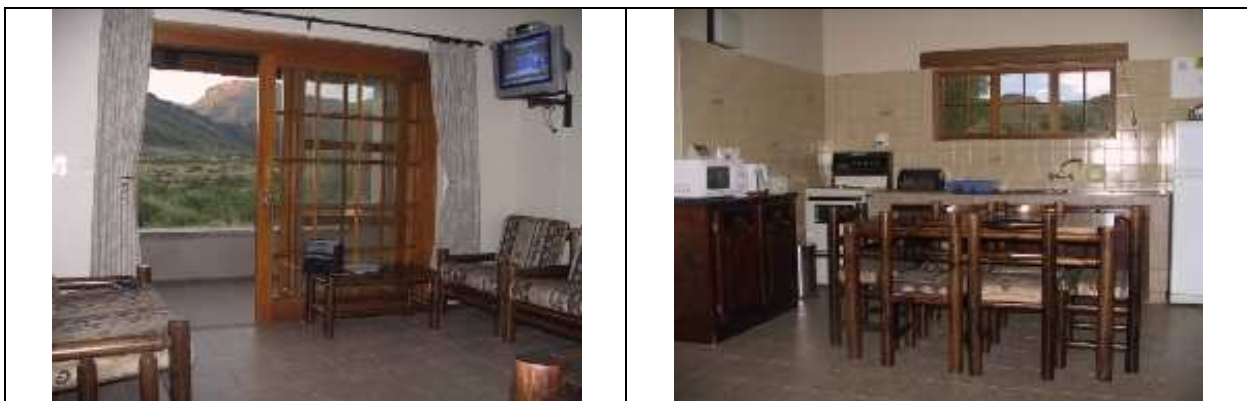
Inside the unit's open plan lounge/kitchen/dining area some furniture may need to be rearranged to provide seamless wheelchair access, but this is easily achieved. The same arrangement of chairs applies to the dining table. This table aside there the kitchen is relatively accessible although there is no clearance under the sink or stove.

The open plan lounge/dining/kitchen living space

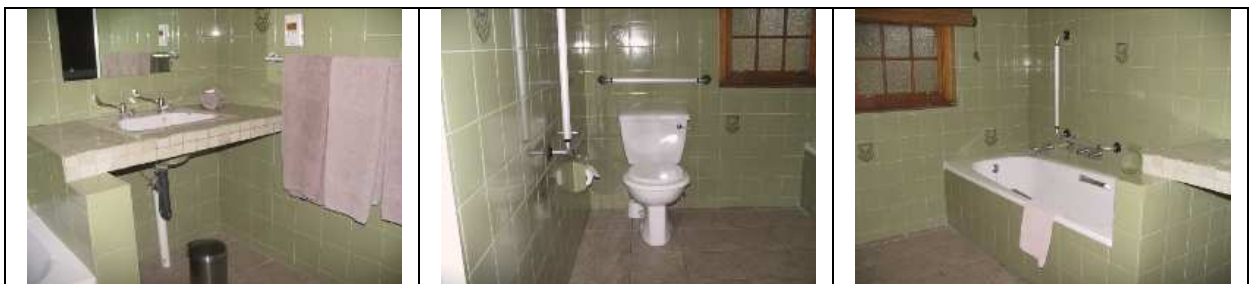
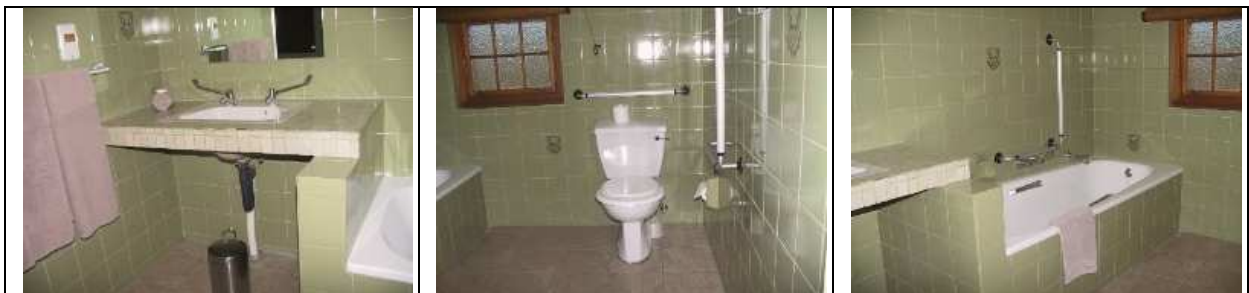
Guest Cottage ABLUTIONS: In the identical but inverse accessible en suite bathrooms, the basin set-up meets the necessary access specs with good clearance, lever taps and a well appointed mirror. The toilets have good and bad points in terms of their access. There is sufficient space alongside the toilets for a person to transfer or be transferred to and from the toilet. The rear grab rail is positioned correctly, but the adjacent one is positioned too far forward and the park management has been encouraged to shift it closer to the toilet to meet the required specs. There is also no basin or water supply within reach of someone using the toilet. However the ablutions' main shortcoming is the baths ... presently the units only have baths with grab rails. This will prevent many mobility challenges guests from using a facility that is designed with the intention of being accessible because they will not have the necessary strength to transfer to and from their wheelchairs into the bath. The park management has been encouraged to remove at least one of the baths and to replace it with a roll-in shower built to the correct specifications. Alternatively they have been given an option to add a fold down seat at the head of the bath and to insert a sliding height adjustable detachable shower on the wall to allow wheelchair users to transfer onto this seat and use the facility as a shower. Until the recommendations are realized the bath is also hampered for those strong enough to transfer into it because the grab rail is positioned too far forward

Bathroom East showing basin, toilet and bath

Bathroom West showing basin, toilet and bath

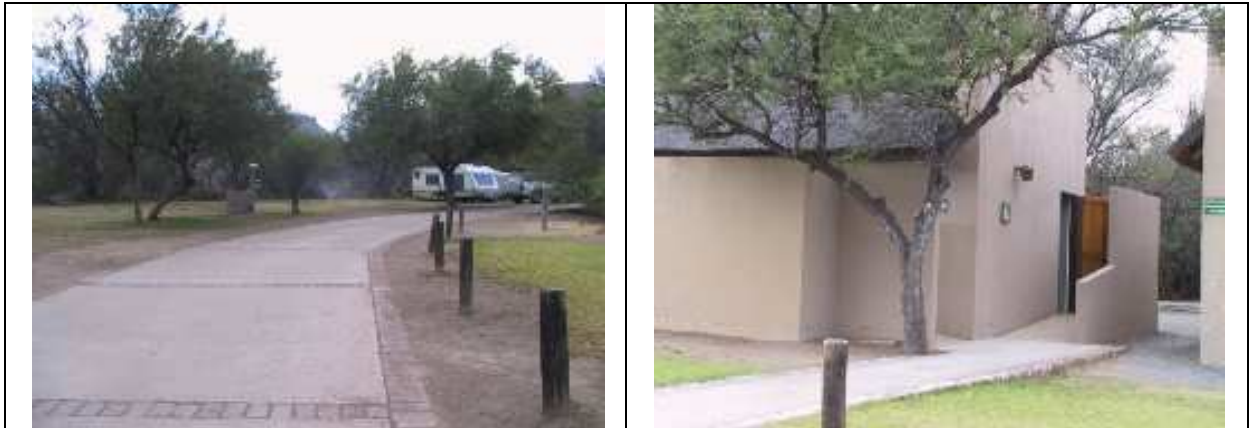
Campsite Accessibility: The park's campsite is generally adequately accessible. The designated area is all flat and while the sites are grassed, there is a concrete road that will facilitate movement from a site to the ablutions. There is a separate unisex accessible ablution which has a wide and level concrete access path culminating in a shallow ramp into the chamber.

Karoo National Park Campsite

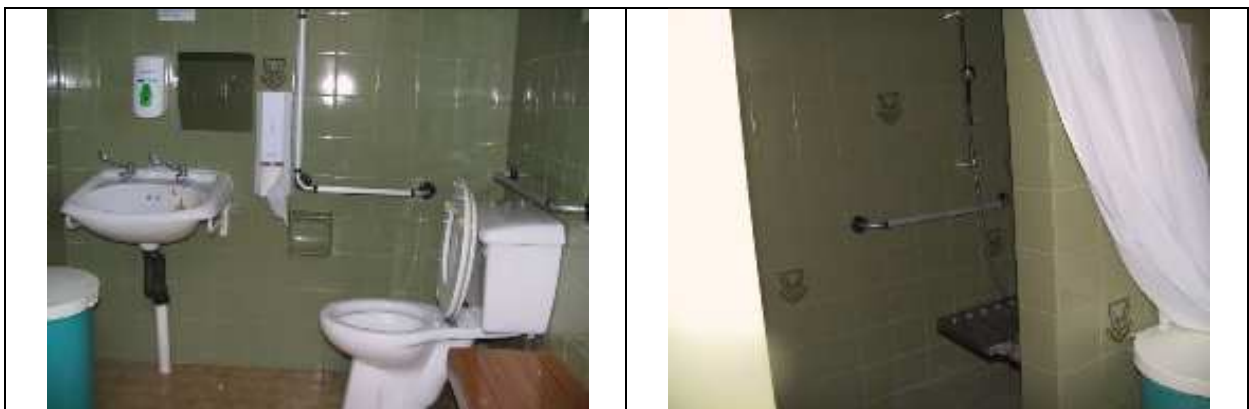
The ablutions have a toilet and basin that both meet the necessary specs for use and the basin is within reach of someone using the toilet which is always ideal. The roll-in shower is a little cramped being in a confined alcove. The toilet seat is an old design metal job and should be replaced with a more modern one meeting the size and composition requirements when next the park does maintenance to the facility.

Karoo National Park Campsite Ablutions
